Indonesian Journal of Science & Technology

Risk-Based Leak Analysis of an LPG Storage Tank: A Case Study

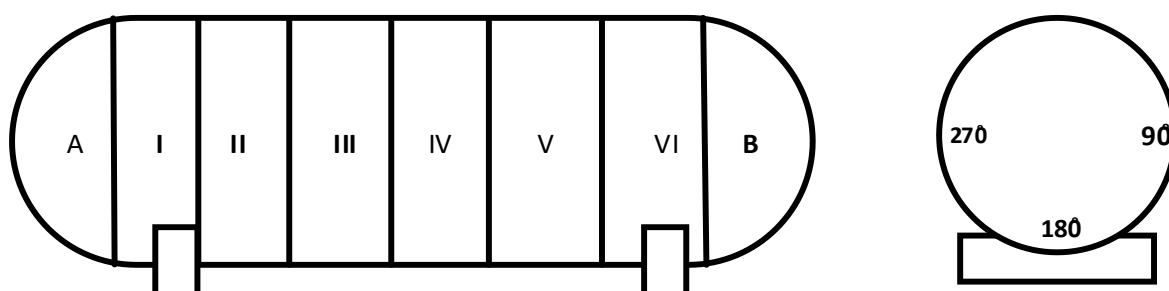
Figure 2. Set up inspection for LPG storage tank.

The data collection scheme is illustrated in **Figure 2**. The layout of the LPG storage tank inspection was divided into six spot shells and two heads, which were each further divided into ten measurement points. Each of the spot shells and heads was examined at three points between the angles of 90, 180, and 270°. The head section was divided into two parts, namely heads A and B. The inspection method for measuring the LPG storage tank's condition used the usually effective category, which has a confidence level of 60 to 80% and nominally 20% ultrasonic manual scanning coverage. Several nomenclatures and symbols used in this study are presented in **Tables 1** and **2.**

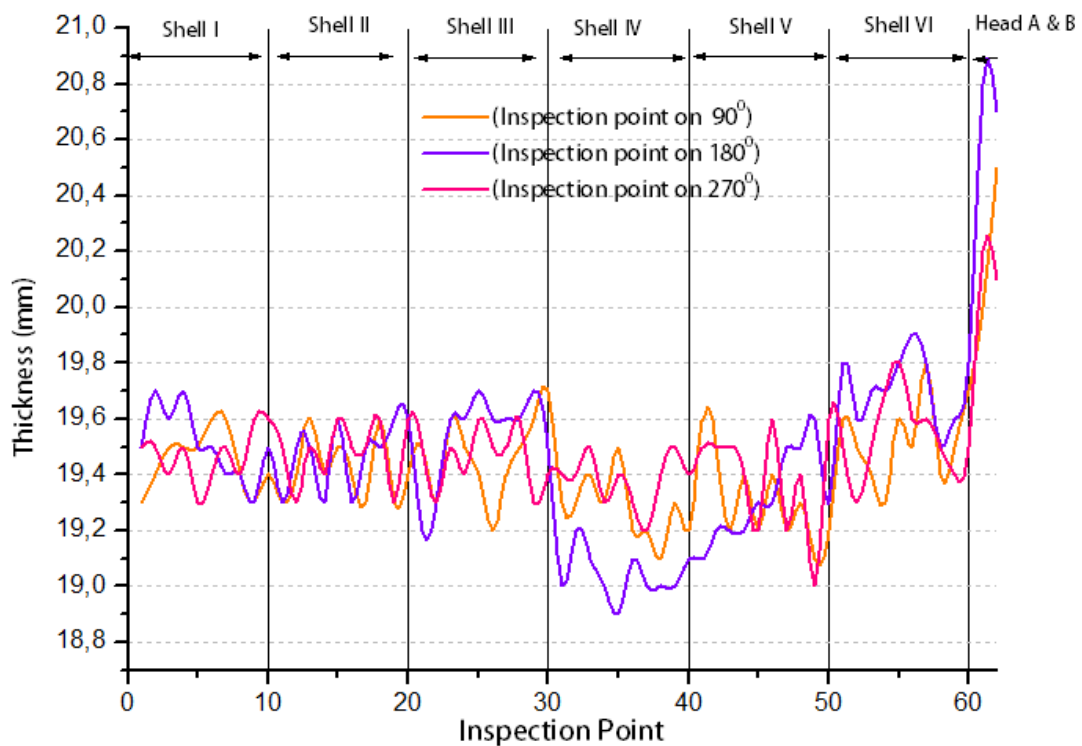
Figure 6. The data thickness of the LPG storage tank wall.

The measured thicknesses of the LPG storage tank were analyzed and compared with previous measurements. This method served as a reference for determining the short-term corrosion rate. The comparison results were used to obtain information on all the examined spots and shell II, which had a

significant thickness difference. Shell II exhibited more corrosion than did the other areas. These data show that each shell had a different amount of corrosion. A comparison of the LPG storage tank test results with the previous inspection is shown in **Figure 7**. This test is a comparison of the last data obtained from the historical inspection data.

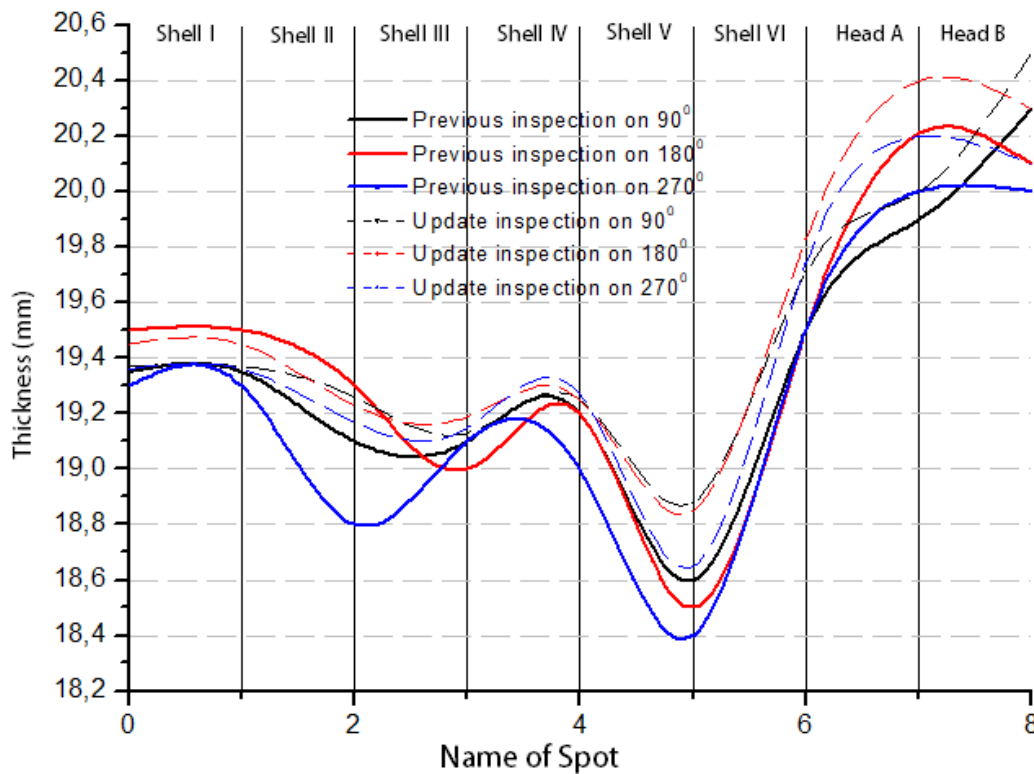
Figure 7. Comparison of the smallest data thickness from the previous inspection period to the current one.

Some information is obtained based on a comparative evaluation of the wall thickness and analysis of short-term corrosion rates. Shells II and I have the highest and lowest short-term corrosion rates, respectively. Shell II must be prioritized when investigating corrosion hazards. The short-term corrosion rate analysis was carried out using Equation [4], and the results are shown in **Figure 8**.

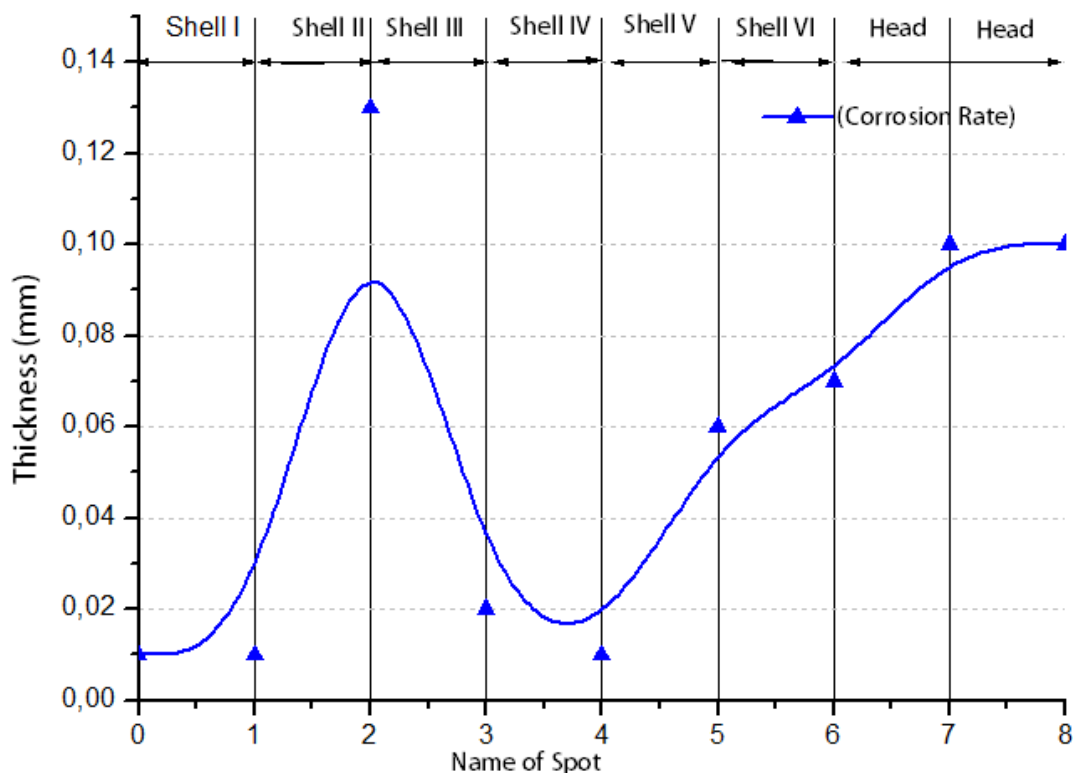
Figure 8. The calculated results of the short corrosions rate of the LPG storage tank.

The long-term corrosion rate was calculated using Equation [5]. The analysis results show the largest value of 0.041 mm/y on shell V and 0.15 mm on head A. After discerning the corrosion rate, the next process was to determine the minimum thickness (T_{min}) on the spotted shell and head using Equations [6] and [7], respectively. The values of T_{min} on the spot shell and head were 14.53 mm/y, and 14.47 mm/y, respectively. The difference between the wall thickness of the spotted shell and T_{min} was 4.37 mm. This value indicates the need to be aware of the dangers of corrosion and cracking. However, the dangers arising from external factors must also be considered.

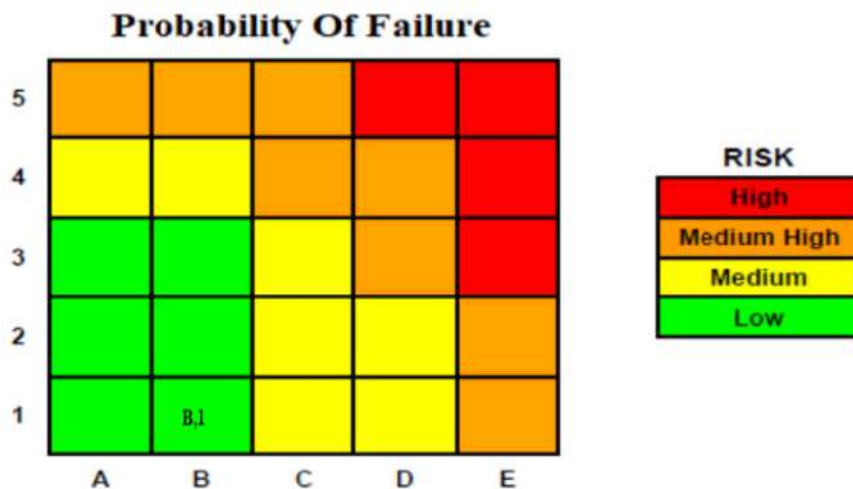
Figure 9. The results of the risk of LPG storage tank using *PoF* analysis.

The risk determination, based on the *PoF* value combined with the effectiveness category, produced a B rating of 1. The risk of the LPG storage tank was low. The results of the risk analysis in accordance with *PoF* are shown in **Figure 9**.

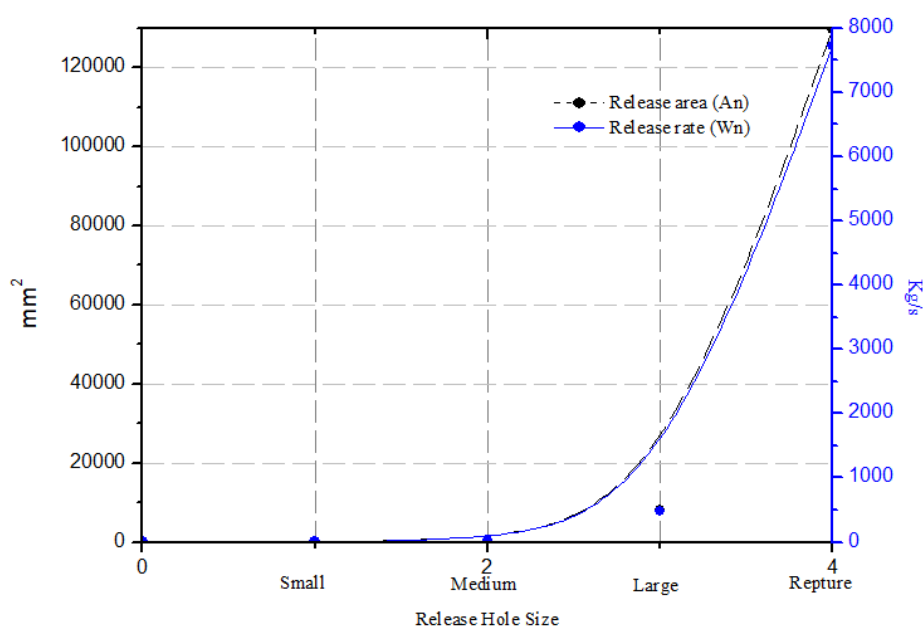
Figure 10. W_n comparison of LPG from each hole area.

First, the leak rate (W_n) was determined by locating the area of each leak hole (A_n) using Equation [16]. The calculated area of each leak hole is listed in **Table 9**. After obtaining each leak hole area, the next step was to determine (W_n) for each of them. This included small, medium, large, and rupture holes. The leak rate (W_n) was calculated using Equation [15]. A comparison of the results (W_n) between the holes is shown in **Figure 10**.

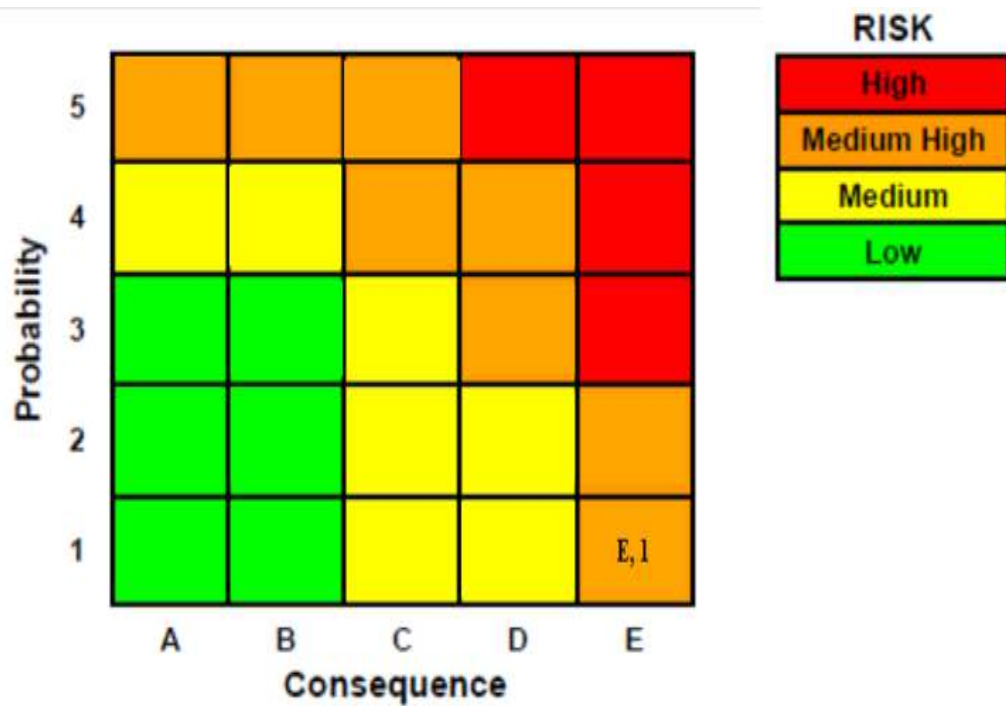
Figure 11. The results of the risk level calculation.

also high. The results of the *PoF* and *CoF* analyses are shown in **Figure 11**, which also shows that the LPG storage tanks had a medium-high level of risk. Therefore, there is a need for supervision and inspection to ensure that the equipment safety system operates effectively.
